WASP REVIEW OF UNPERMITTED SPILLS FROM SEWAGE TREATMENT WORKS

PART1: 735 “illegal” discharges of untreated sewage from 13 Thames Water STWs 2018-2020

Peter Hammond, Windrush Against Sewage Pollution (WASP), October 2021

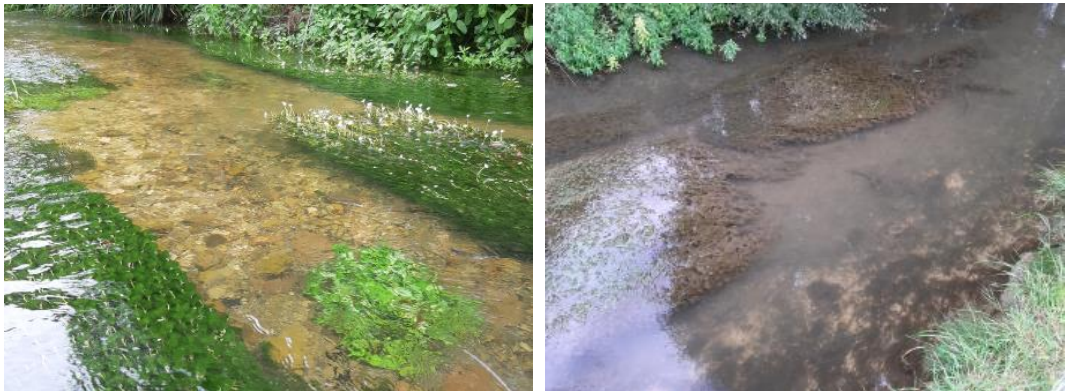
Ampney St Peter STW does not spill early but is subject to significant groundwater infiltration and “dry” spills resulting in a dramatic difference between the state of the Ampney Brook upstream and downstream of sewage sources.

Ampney Brook above sewage sources (30/06/21) Ampney Brook below sewage sources (10/07/20)
Figure 1 Ampney Brook upstream and downstream of the STW outfall Images: WASP founder Ashley Smith

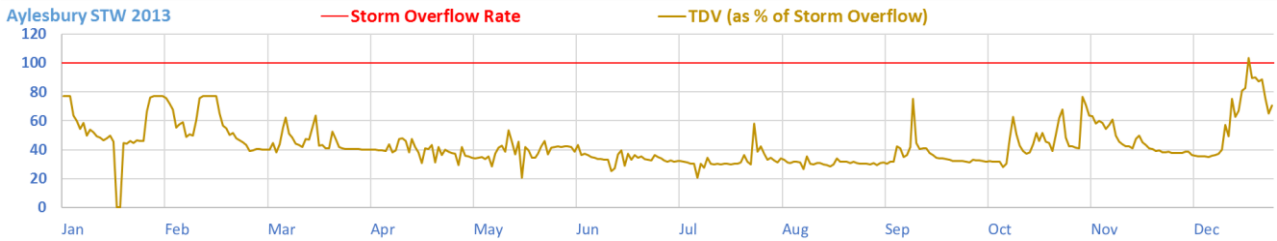
When viewed as the EA receive the same data (Fig. 2), a single total flow value per day, it looks less rectilinear and less flattened, and therefore less suspicious. Whereas Fig. 1 arouses suspicion of anomalous and unnatural flow, Fig. 2 does not.

Figure 2: total daily flow curve for 2013 smoothing out the rectilinear, clipped edges of 15-min flow curve in Fig 1

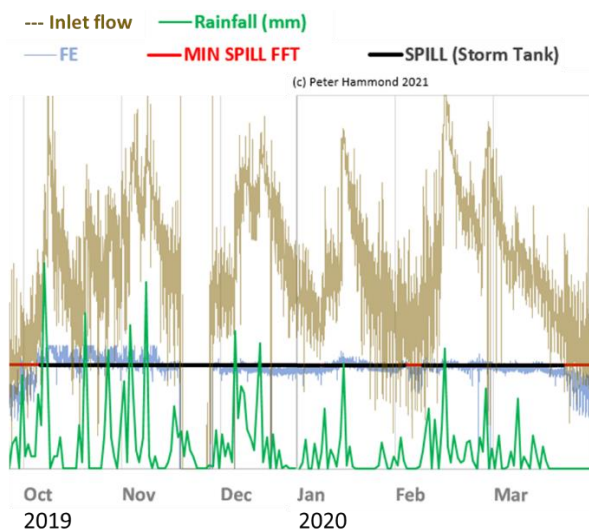
Fairford STW has two meters which measure flows into the site from terminal pumping stations (Horcott Road and Moor Farm). They are not MCERT standard and were only connected to Thames Water's central SCADA system in 2018. During spills, the difference between their sum and the effluent flow is a reasonable estimate of what is discharged to the River Coln, especially over a significant time period when travel through the site and return flows have negligible effect. Between October 12th 2019 and 24th March 2020, the Event Duration Monitor (EDM) at Fairford STW recorded 165 days of almost continuous spilling (**Fig. 1**). During this time, the works received 870 million litres of untreated sewage and discharged 500 million litres or so of treated effluent, so as many as **370 million litres of sewage may have been spilled to the River Coln**.

Figure 1: untreated sewage flow (brown curve) into and treated effluent (blue curve) out of Fairford STW during 165 days of almost continuous spilling of untreated sewage (black horizontal segments)
